United States Environmental Protection Agency Environmental Monitoring Systems Laboratory P.O. Box 93478 Las Vegas, NV 89193-3478 TS-PIC-88704 March 1988

AERIAL PHOTOGRAPHIC ANALYSIS OF WASTE DISPOSAL, INCORPORATED Whittier, California

This report presents a historical analysis of the Waste Disposal, Incorporated facility located in Whittier, California. Archival aerial photography spanning 60 years (1928-1987) was used as the primary information source for the preparation of this report.

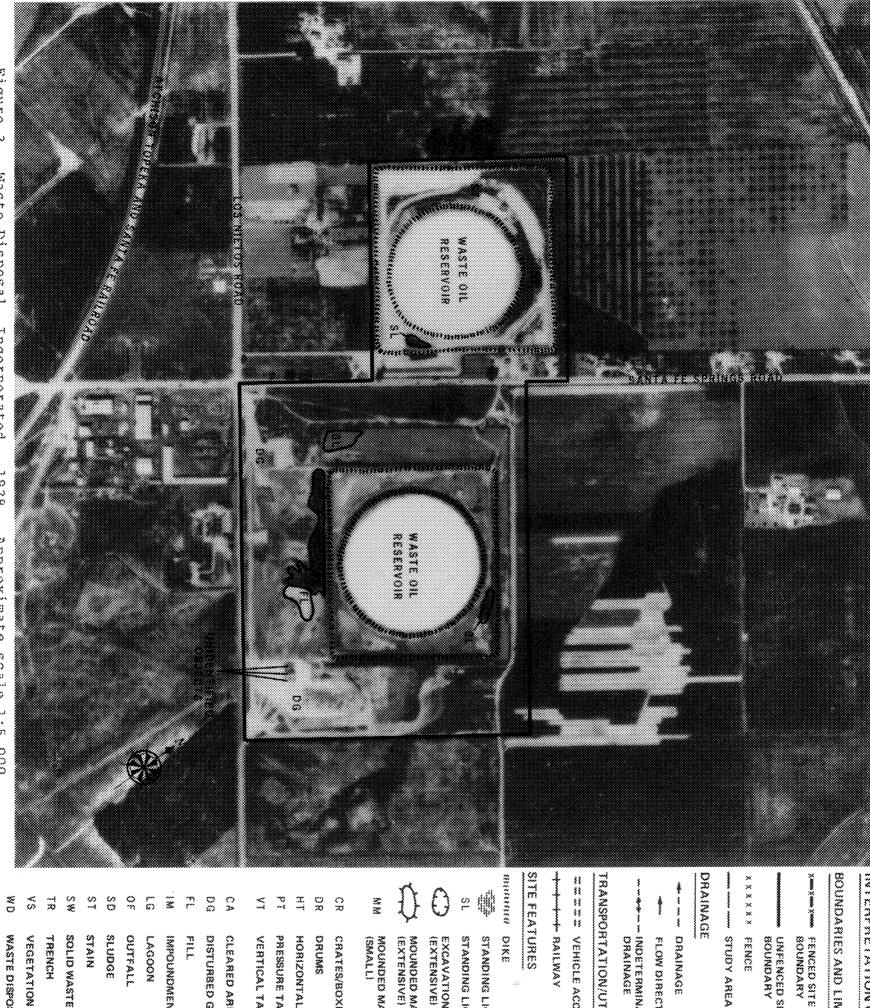
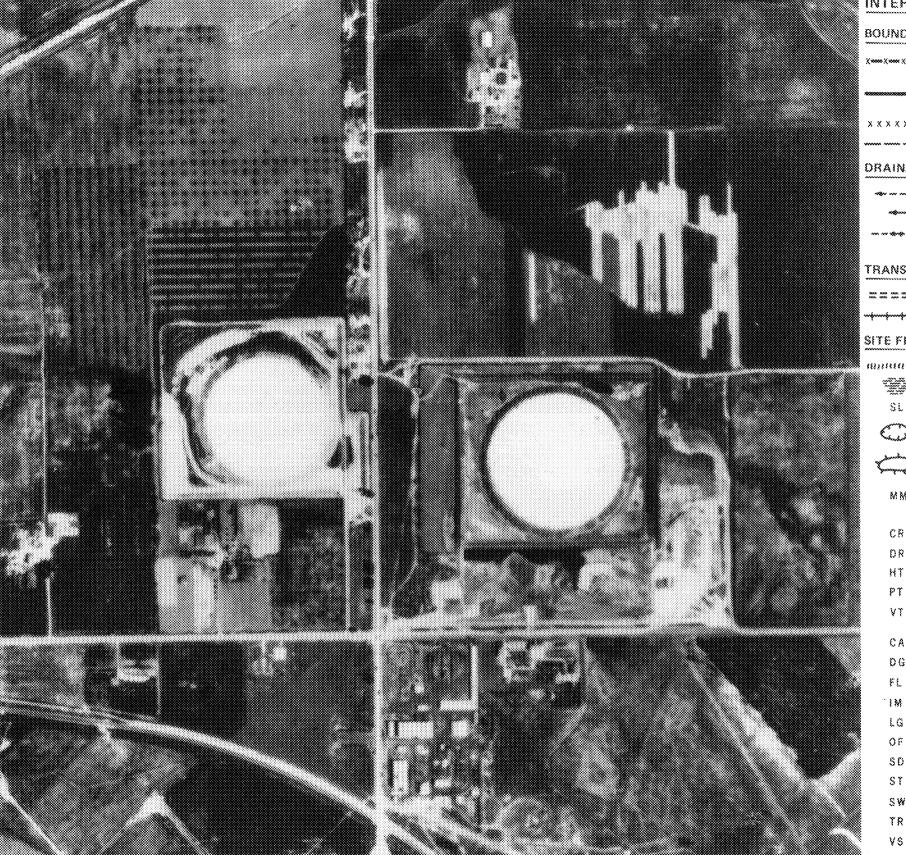
1928 (FIGURE 3)

The Waste Disposal, Incorporated facility was operational on this photo date. The poor quality of the photograph did not permit identification of small features within the site. Two large, waste oil reservoirs occupy most of the facility property. The reservoirs appear identical in construction and size. The walls of the reservoirs appear to be concrete, while a secondary earthen berm surrounds the reservoirs. The reservoir diameters are approximately 500 feet. Both reservoirs appear to have covers of unknown material across the top. There are no identifiable support structures within the site. Three unidentified objects are noted in the southeast corner. The objects are possibly vehicles. A large pool of dark liquid is visible outside the southern earthen containment wall of the easternmost reservoir. A smaller pool is noted in the northeast corner, inside the earthen wall. Staining is visible around the westernmost reservoir. A pile of fill material is noted adjacent to the large pool of standing liquid. Land use surrounding the site to the north, south, and east is mostly agricultural. Predominantly oil fields and oil-related industries occupy land west of the site.

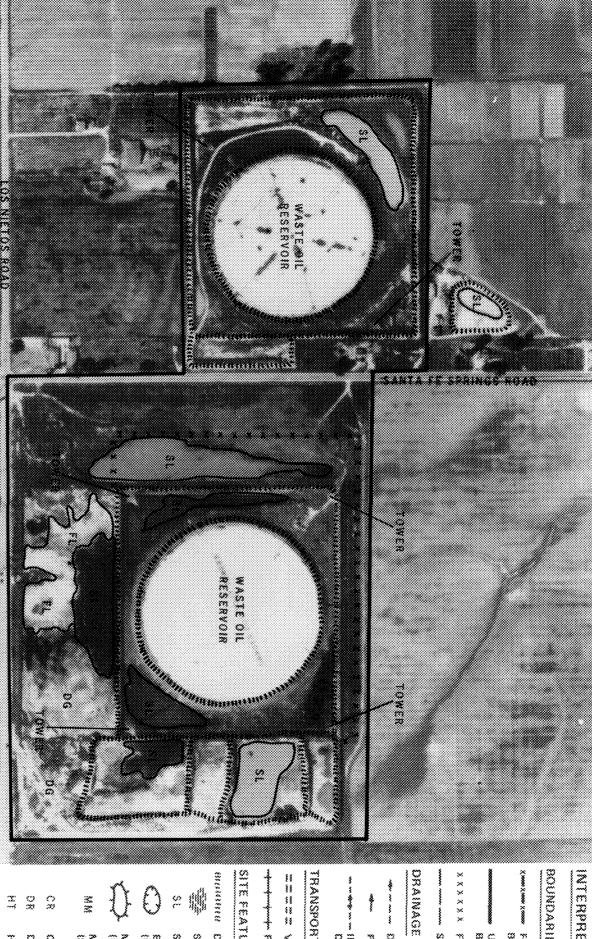
FEBRUARY 20, 1937 (FIGURE 4)

There is no visible change to the two large reservoirs at the Waste Disposal, Incorporated facility since the 1928 photo coverage (Figure 3). The firmness of the reservoir covers can be attested to by the signs that have been painted on their surfaces. Staining is noted at the joining seams of the westernmost cover. Puddles of standing liquid are noted around both reservoirs. The lighter toned puddles appear to be standing rainwater. The darker toned puddles are probably rainwater covering heavily stained ground. Four, unlined, waste lagoons are visible east of the reservoirs. The deteriorated condition of the containment walls surrounding these lagoons suggests that they are no longer in use. Standing liquid within the containment walls is probably standing rainwater. Towers have been erected within the earthen containments of the reservoirs. No support structures are visible within the site. A small unlined impoundment is noted north of the westernmost reservoir. Standing water is visible within the containment. This impoundment does not appear to be associated with the site. Land-use for the surrounding area remains unchanged from that which was previously reported.

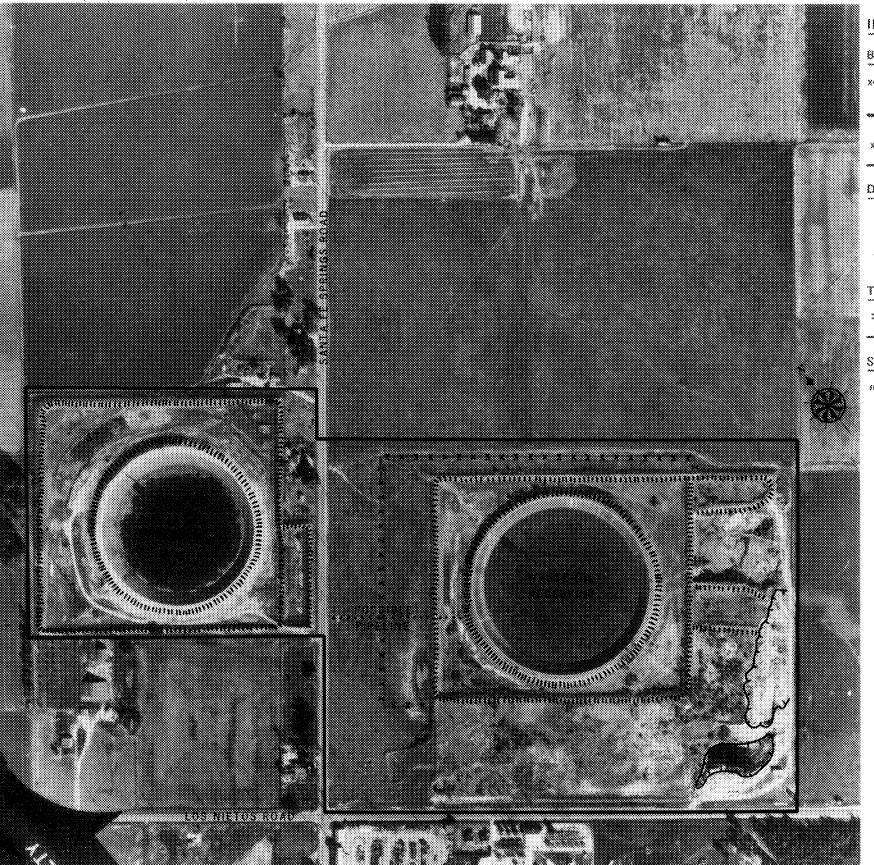
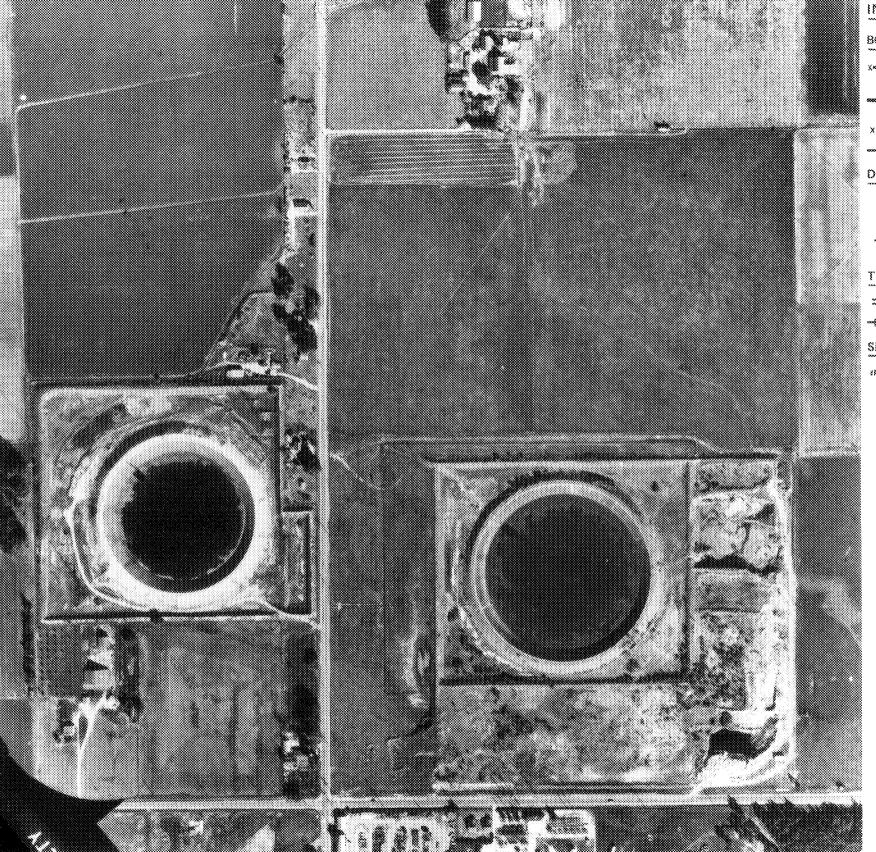
JANUARY 1, 1945 (FIGURE 5)

Clean up of the Waste Disposal, Incorporated facility has occurred since the 1937 photo coverage (Figure 4). The covers have been removed from the two reservoirs and the contents removed. It can now be seen that the reservoirs are concrete lined. All containment walls surrounding the reservoirs are in good condition. The surrounding ground has been scraped and is relatively free of staining. The six towers previously noted have been removed. The four lagoons on the east end of the site have been abandoned. The containment walls are being removed. A pit has been excavated in the southeast corner. This pit contains a dark liquid. A light shrub-like, vegetative growth has sprouted up within the old lagoon containments and south of the eastern reservoir.

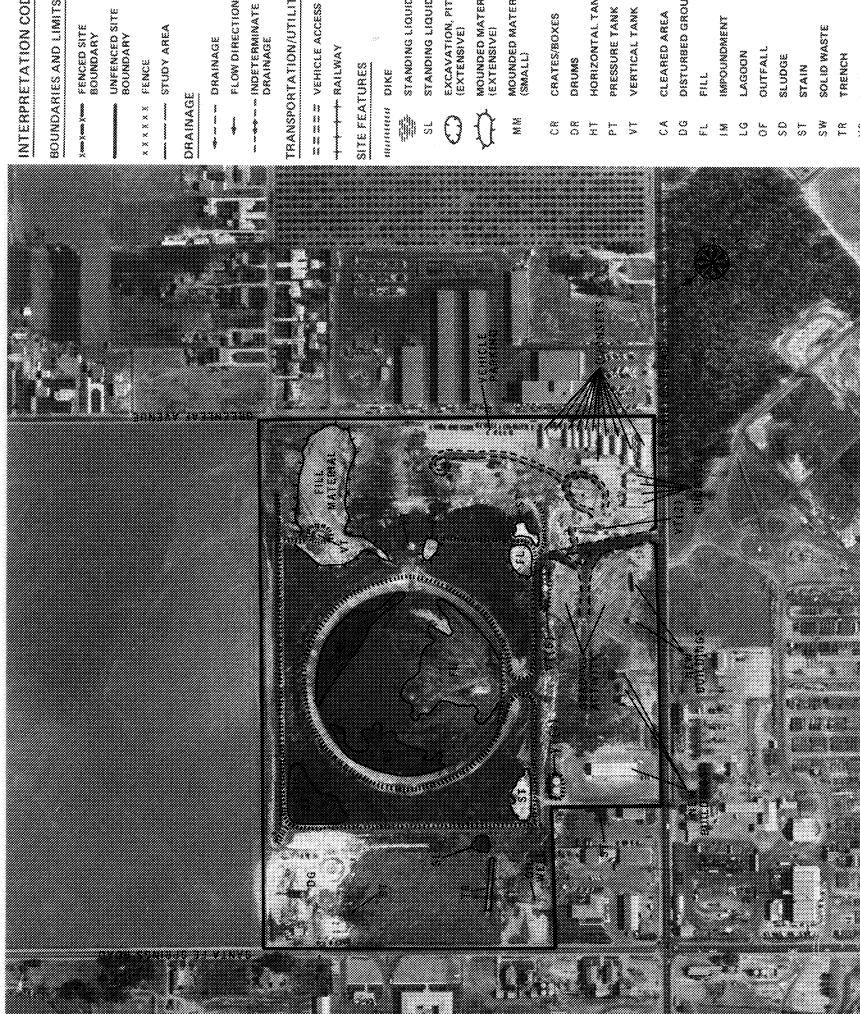
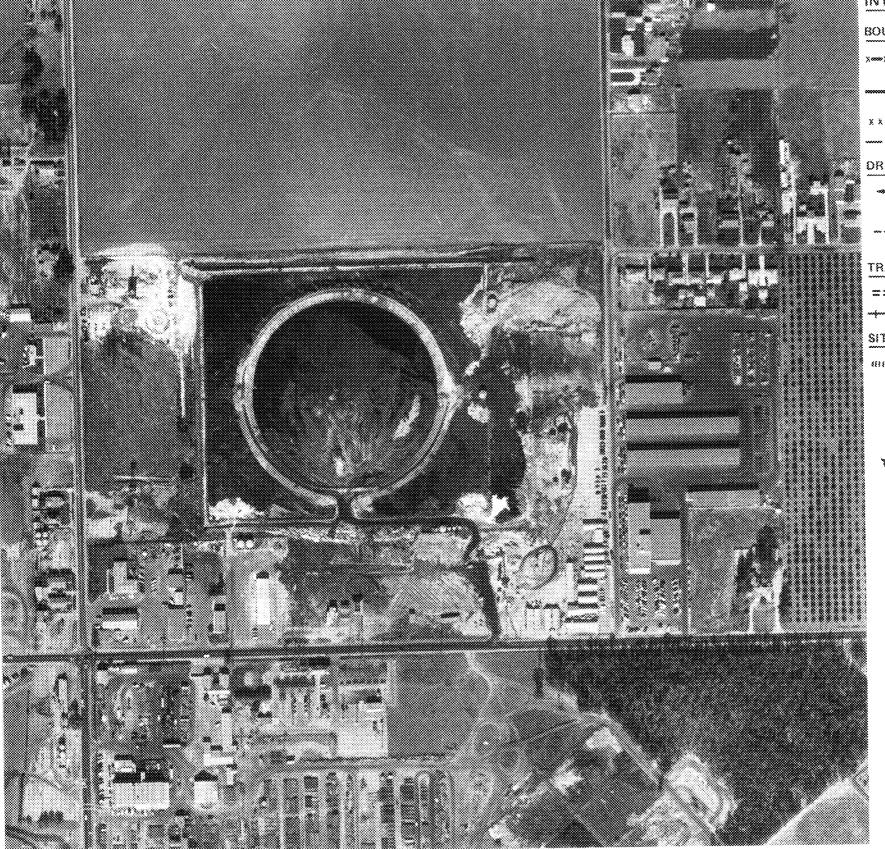
OCTOBER 19, 1953 (FIGURE 6)

A large change has occurred at the Waste Disposal, Incorporated facility since the 1945 photo coverage (Figure 5). The westernmost reservoir has been torn down and commercial facilities now occupy the area (not shown on photo). The site has been decreased in size by this and a commercial operation southwest of the remaining reservoir. The site is now bounded by Santa Fe Springs Road to the west, Greenleaf Avenue to the east, Los Nietos Road to the south, and an empty field to the north. The remaining reservoir has changed little since 1945. A crossover access ramp has been constructed along the southern edge of the reservoir. Fifteen quonset hut type structures have been set up in the southeast corner of the site. These structures appear to be new commercial enterprises and not linked to the waste disposal facility. These structures have been set up over the area where a pit had been located on the 1945 photography (Figure 5). The land east of the reservoir, which previously contained waste lagoons, has now been cleared. A large mound of fill material is noted in the area. To the west of the reservoir is an area of disturbed ground which appears to be construction activity. An empty, unlined trench, an oil well, and a small pond of standing liquid are also visible in this area. The area south of the reservoir contains five buildings and nine vertical tanks. Staining, fill material, and standing liquid are noted within the reservoir itself. The outer, secondary containment, wall remains intact except for the eastern wall near the fill pile. Several smaller piles of fill material are also noted in the area.

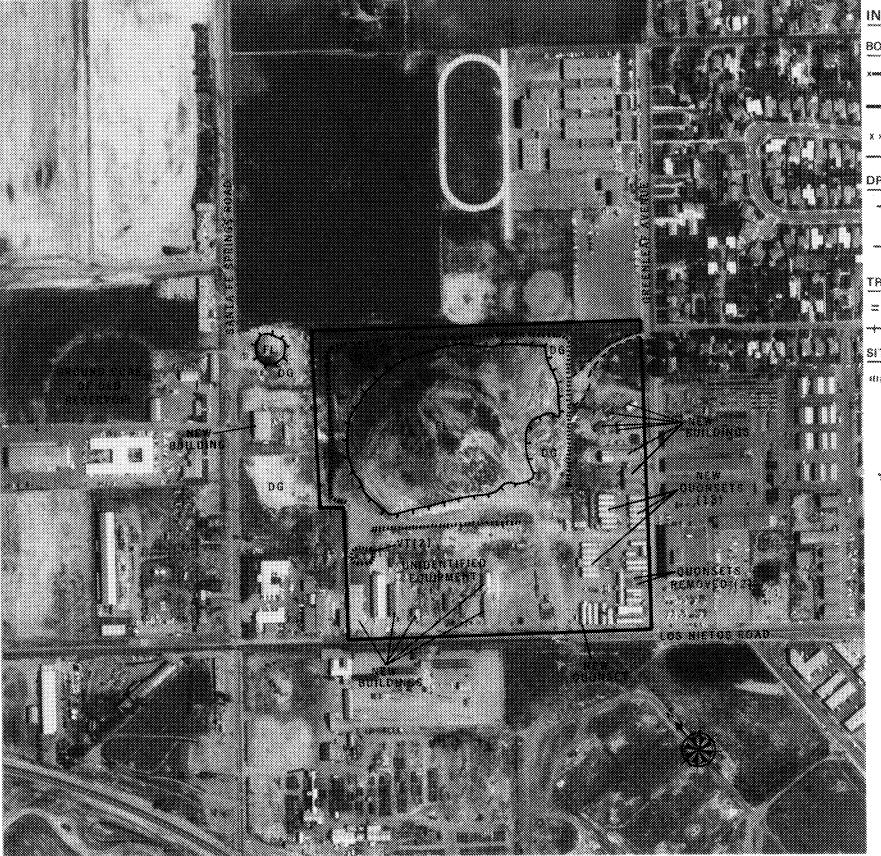
FEBRUARY 28, 1963 (FIGURE 7)

Commercial facilities now surround the Waste Disposal, Incorporated facility on the south, west, and east. A school has been constructed to the north. The area of the reservoir is being filled in. A large mound of fill now covers the reservoir and the area between the reservoir and outer secondary containment wall. South of the fill mound, several new buildings have been added. Insufficient information is available to determine which, if any, constitute the Waste Disposal, Incorporated facility. Nineteen quonset huts and six new buildings have been added to the east side of the site. Two vertical tanks remain within the area.

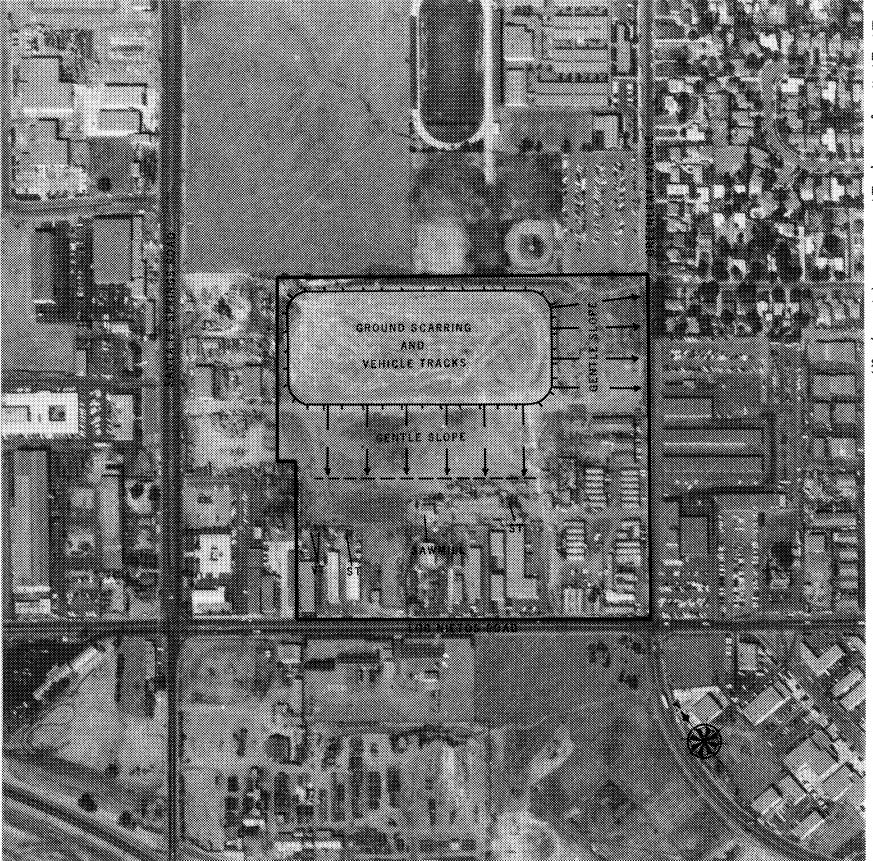
SEPTEMBER 23, 1968 (FIGURE 8)

The major change noted at the Waste Disposal, Incorporated facility since the 1963 photo coverage (Figure 7) is in the area of the waste reservoir. The area has been completely filled in and leveled. No traces remain of the reservoir nor the old waste lagoons. The ground is cleared and devoid of stains. Ground scarring and vehicle tracks crisscross the top of the fill mound. New commercial enterprises have been established west and south of the site. Four buildings have been removed directly east of the fill mound. Two vertical tanks and minor staining are noted within the study area.

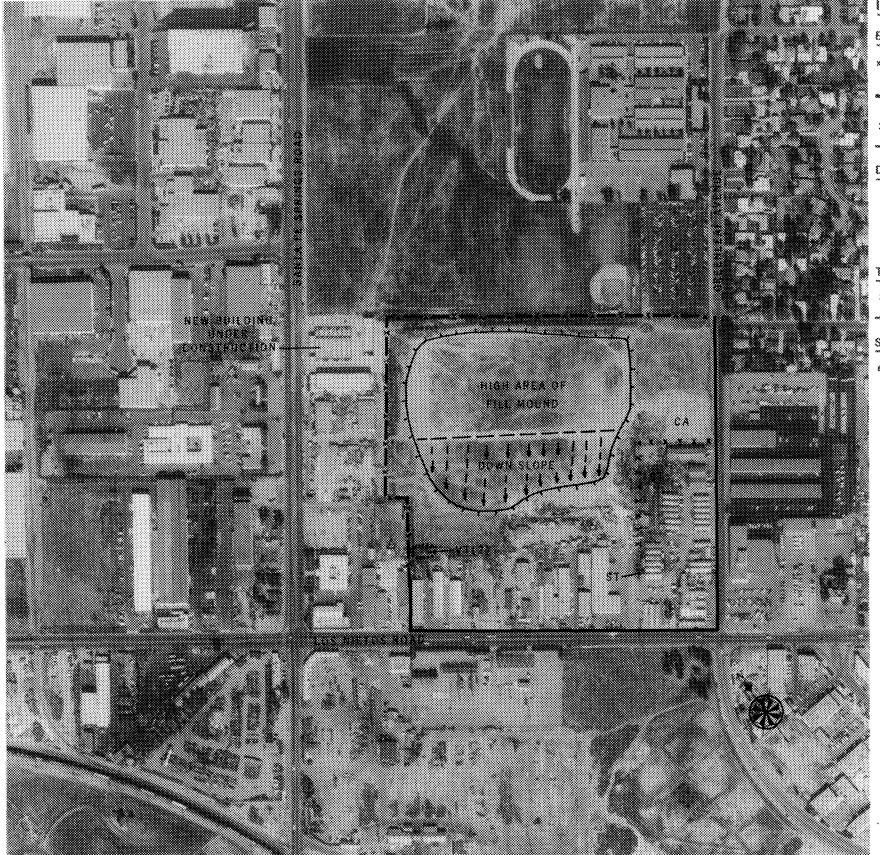
OCTOBER 30, 1972 (FIGURE 9)

Little change is noted at the Waste Disposal, Incorporated facility since the 1968 photo coverage (Figure 8). Excavation and clearing activity has occurred east of the fill mound. Minor staining is visible near the commercial establishments along the east side of the study area. Two vertical tanks are also noted. There is no evidence of waste disposal activity currently being conducted at the facility. Perimeter fencing partially encloses the site.

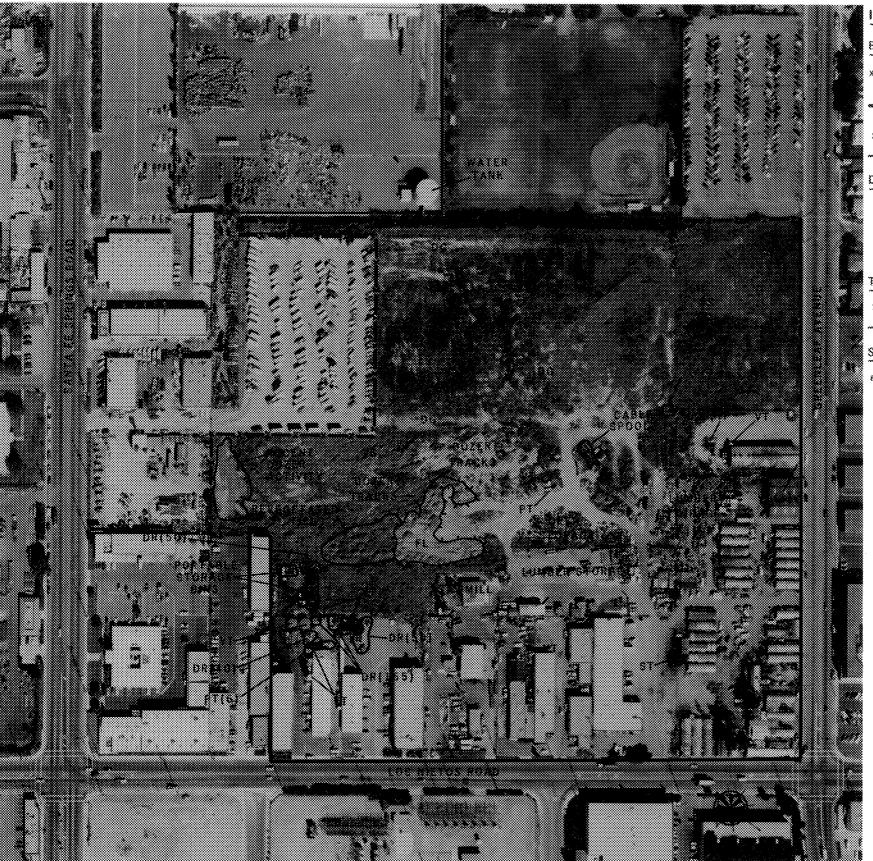
OCTOBER 27, 1983 (FIGURE 10)

Changes noted at the Waste Disposal, Incorporated facility since the 1972 photo coverage (Figure 9) have mostly occurred in the area of the fill mound. The western end of the mound has been paved and made into a parking lot. Old dozer tracks are visible along the southern slope of the mound, and recent dozer activity is visible south of the new parking lot. The parking lot is fenced, separating it from the fill mound, and appears to be related to the adjacent commercial boating facility. Vegetation growth has covered the fill mound and the open areas between the mound and commercial facilities. Patches of disturbed ground are visible within these vegetated areas. A large fill pile also occupies the area. The westernmost facility, within the study area, has 4 vertical storage tanks, 12 rectangular storage bins (portable), approximately 305 drums, and 6 pressure tanks. Six vertical storage tanks, one horizontal tank, and one pressure tank are located in different areas within the remainder of the study area. Vegetation stress noted within the area is probably caused by vehicular activity.

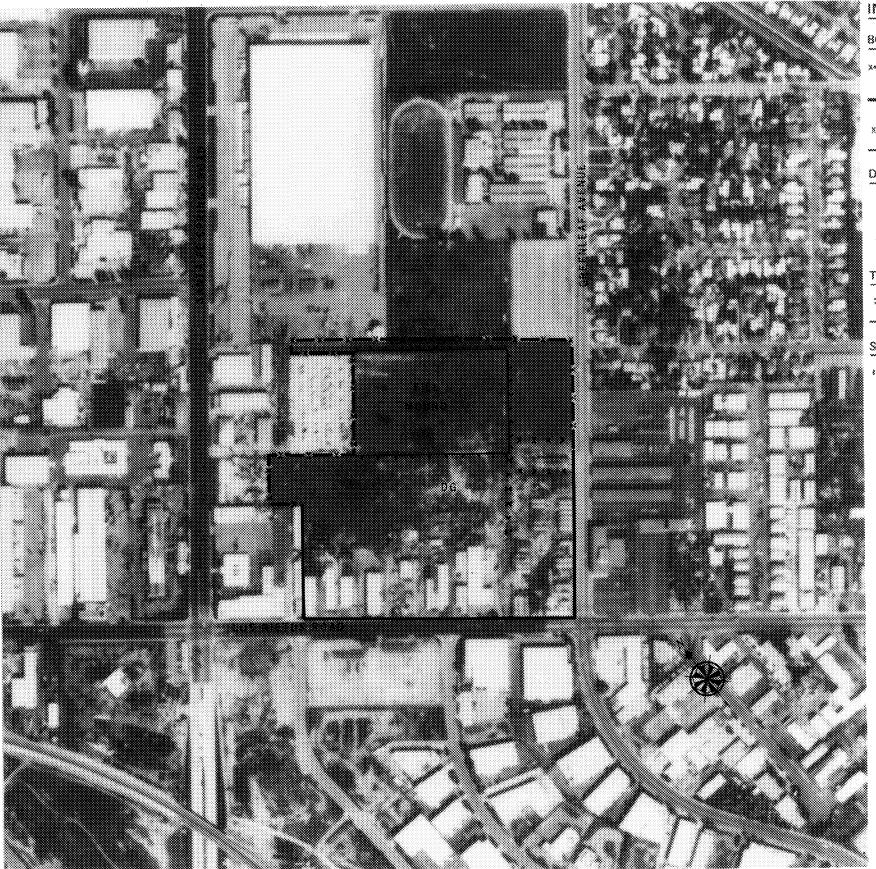
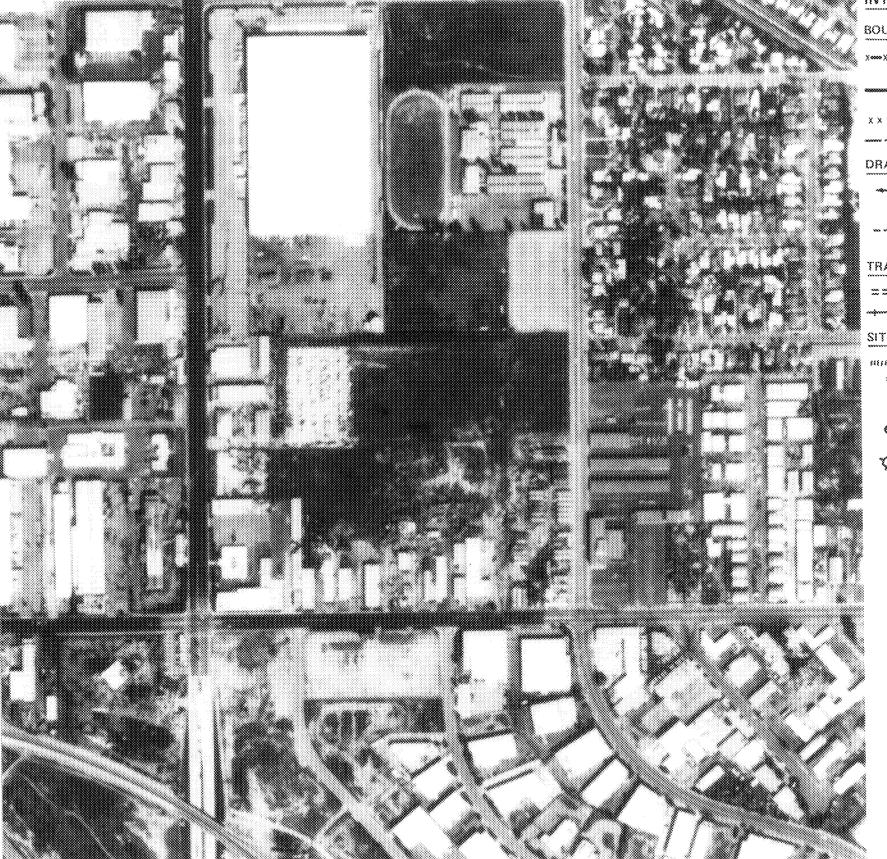
FEBRUARY 10, 1985 (FIGURE 11)

Due to the poor quality of this photograph, small details were not interpretable. There does not appear to be any visible change at the Waste Disposal, Incorporated facility since the 1983 photo coverage (Figure 10). Vegetation growth within the area has increased. The disturbed ground noted on the photograph appears to have been caused by vehicular traffic.

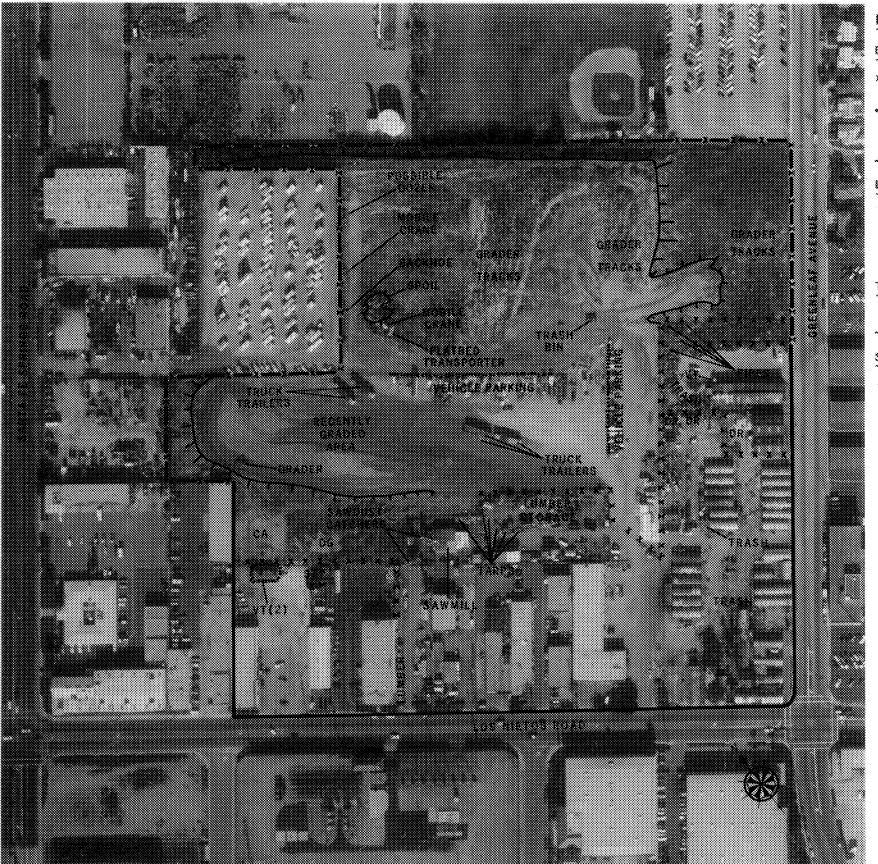
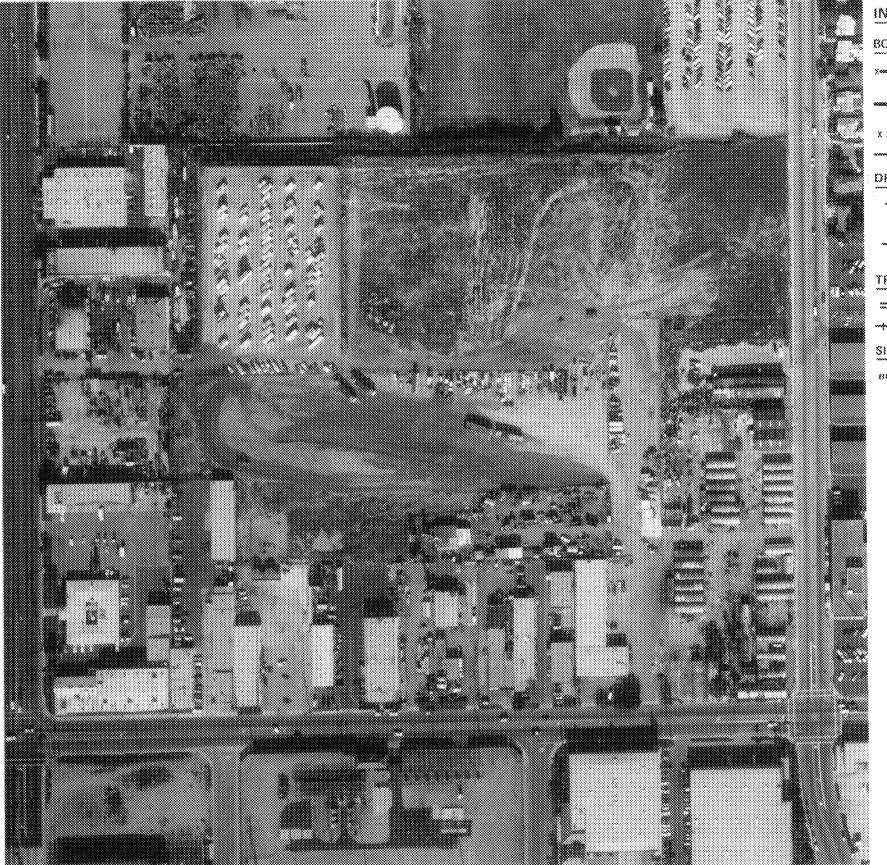
NOVEMBER 20, 1987 (FIGURE 12)

The major change noted at the Waste Disposal, Incorporated facility since the 1985 photo coverage (Figure 11) has been the leveling and grading of the southern slope of the fill mound. Grader tracks are also visible on the surface of the fill mound. Heavy equipment is noted in the area. Two vertical tanks remain at the westernmost facility within the study area. All previously noted drums, storage bins, and two vertical tanks have been removed (Figure 10). This facility presents a neat, recently cleaned, appearance.
